Manhole Inspection Summary

Manhole # S03SS1015MH

Location Address: **5510 NARCISSUS AVE**

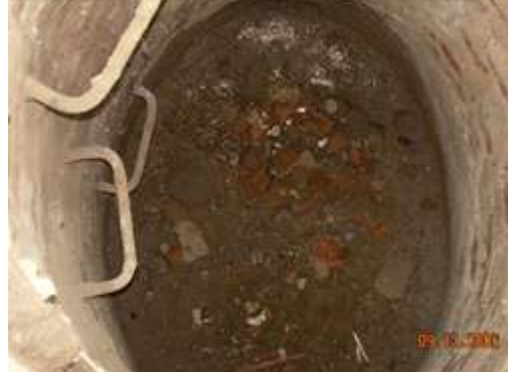
Top View

Corroded steps. Channel debris.

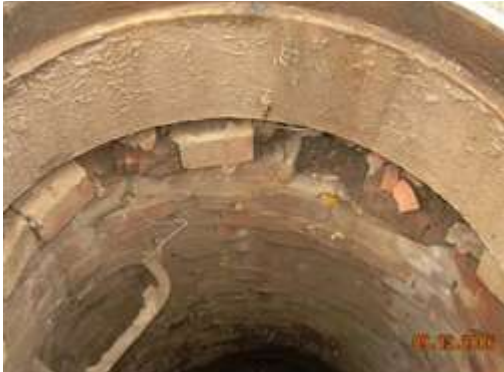
Defect

Frame leaks. Adjustment deterioration, loose brick and infiltration. Corbel and Barrel infiltration.

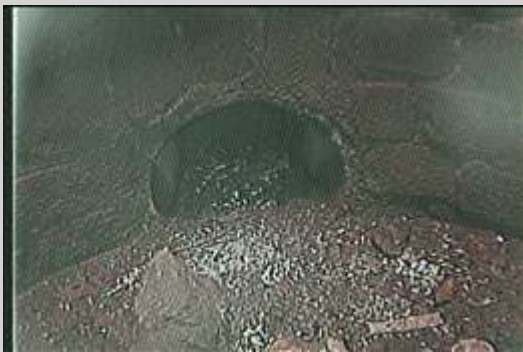
8 in. Circular Gravity Sewer
Pipe Out @ 12 O'Clock

Deposits: ☐ None ☒ **Mud** ☐ Sludge ☒ **Debris** ☐ Grease

Silt Depth: **2** (in.) Deposits Extent: **Medium**
